# Manhole Inspection Summary

Manhole # S45I2\_009MH

Insp Date: **1/7/08 1:55 PM**

**Location** Address: **4700 Prudence St**

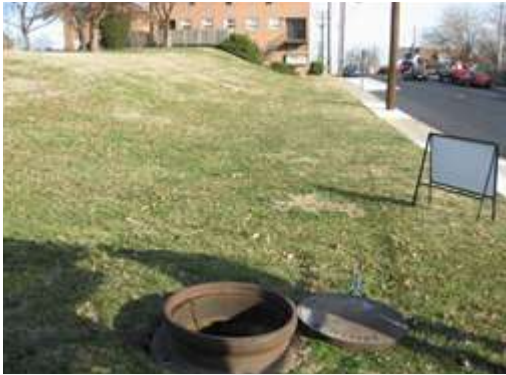
Location View

on grass adjacent to Church St

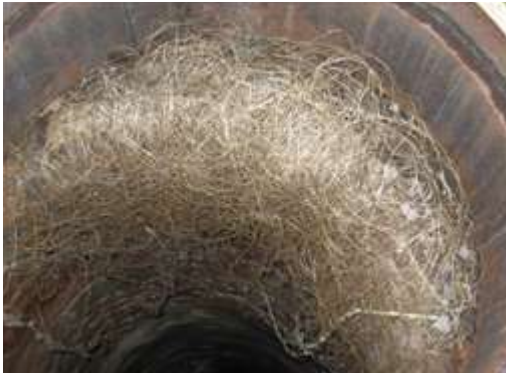
Defect 1

Condition: ☐ Sound ☐ Cracked ☒ **Root Intrusion** ☐ Loose Brick ☐ Deteriorated

Infiltration: ☐ None ☐ Joint ☐ Cracks ☒ **Mortar** ☐ Roots ☐ Wall

grass on chimney

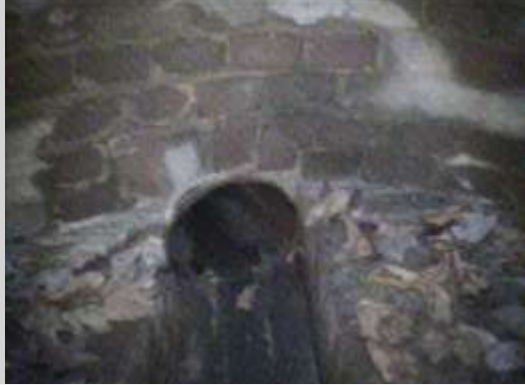
12 O'Clock Outflow

8 in. Circular Gravity Sewer  
Pipe Out @ 12 O'Clock

Pipe Height: **7.2** (in.) Rod and Bar (Angled)  
Pipe Material: **Clay** ☐ Pipe Lined  
Invert Depth: **13.96** (ft.) Flow Characteristics: **Slow**  
Deposits: ☒ None ☐ Mud ☐ Sludge ☐ Debris ☐ Grease  
Silt Depth: (in.) Deposits Extent:  
Infiltration: **None** Pipe Seal Cond: **Sound**

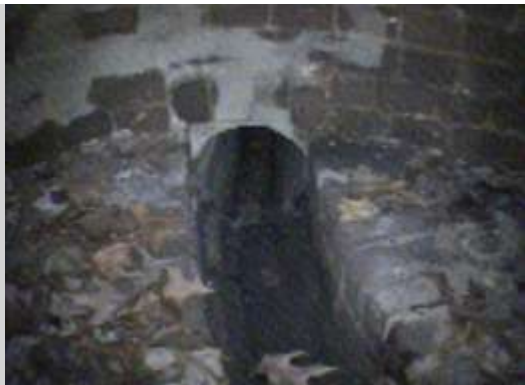
6 O'Clock Inflow

8 in. Circular Gravity Sewer  
Pipe In @ 6 O'Clock

Pipe Height: **7.2** (in.) Rod and Bar (Angled)  
Pipe Material: **Clay** ☐ Pipe Lined  
Invert Depth: **14.02** (ft.) Flow Characteristics: **Slow**  
Deposits: ☒ None ☐ Mud ☐ Sludge ☐ Debris ☐ Grease  
Silt Depth: (in.) Deposits Extent:  
Infiltration: **None** Pipe Seal Cond: **Sound**
